HOSHIZAKI AMERICA, INC.

SERVICE BULLETIN

SB04-0011

Subject: **BROKEN BIN CONTROL BULB COUNTERMEASURE**

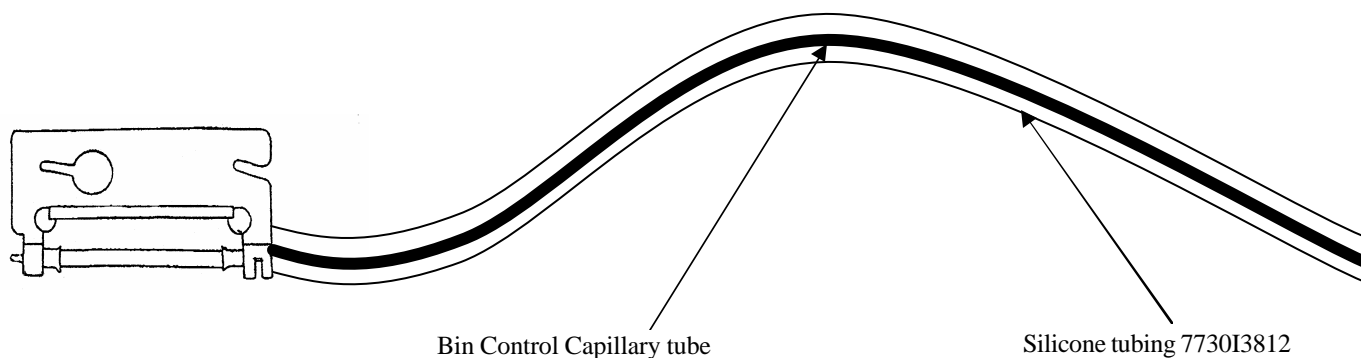
Beginning in March 2004 the KM-280M_H, KM-500M_H, KM-630M_H as well as the KML series will include silicone tubing along the portion of the bin control capillary located in the ice drop zone. **There were also changes made to the mounting bracket and capillary routing on the KML series and the KM-900.** This will help protect the bin control capillary from ice impact “pinging” during the harvest cycle.

Note: Generic picture of bulb holder, capillary and silicone tube. The respective deflector or thermostat extension bracket not shown.

This tubing **will also be added** to all TB0030 and TB0040 bin controls. **When replacing the bin control this tubing should be installed..** One length of tubing will be sent with these kits. **The tubing must be cut to** fit flush against the front cover it will not pass through the front cover, also route the tubing and **capillary** in a matter as to get the least amount of ice “pinging” as well as not to catch water inside tubing.
