HOSHIZAKI AMERICA, INC.

SERVICE BULLETIN

SB07-0001

Subject: KM-501MAH DIP SWITCH SETTING CHANGE.

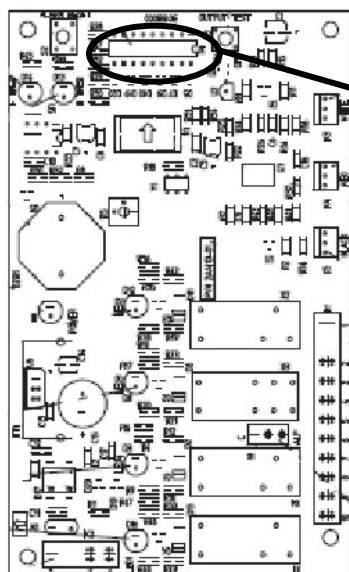
DIP Switch location.

Effective December 2006 the factory setting for DIP switch numbers 1 and 2 have been changed for the KM-501MAH series of ice makers. The new setting is DIP switch number 1 in the OFF position and number 2 in the ON position. This will change the defrost completion time from 60 seconds to 120 seconds.

If you are experiencing freeze up issues on these units, we are suggesting that a freeze up check list be completed (SB03-0003) If no other problems which could cause a freeze up are found, you should adjust DIP switch 1 and 2 to the new factory setting shown above.
