HOSHIZAKI AMERICA, INC.

SERVICE BULLETIN

SB12-0001R1

SUBJECT: Change in KM Series Cleaning Valve.

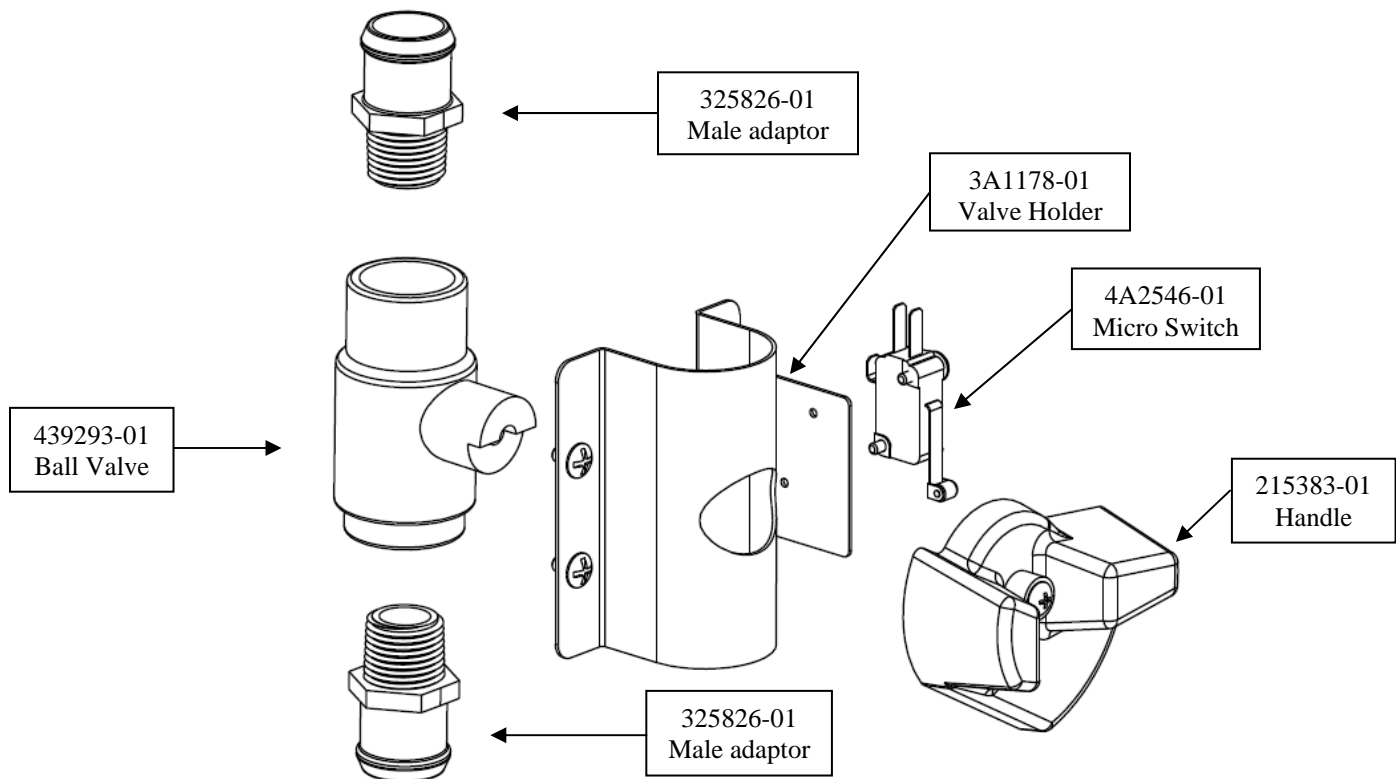
Beginning in March 2011 the manual cleaning valve assembly for the KM series has changed. The two male adaptors have changed design and this new design no longer requires the use of the O-ring 7611-P018. The O-rings have been eliminated and the adaptors are now sealed by Teflon thread tape. Note: In the event of a water leak around the male adaptor do not try to tighten further. Remove male adaptor, apply new thread seal tape and re-install adaptor. Care should be taken not to over tighten adaptor as cracking may occur.

See below for a diagram of the new assembly and current part numbers.
