HOSHIZAKI AMERICA, INC.

SERVICE BULLETIN

SB95-0004

SUBJECT: DB-130/200 PUSH BUTTON SWITCH REPLACEMENT

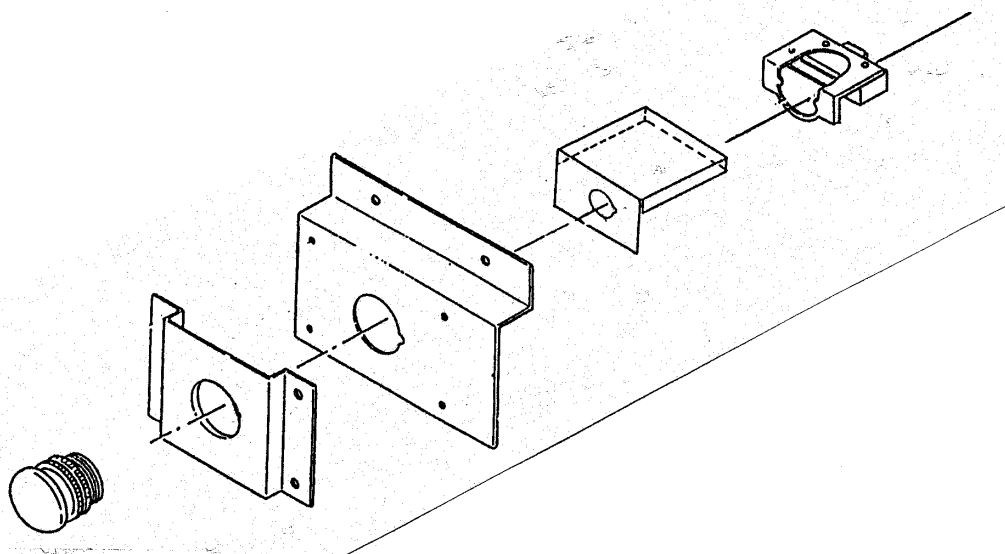
Due to reports of moisture damaging the DB push button switch, we have added a protective barrier covering the switch. The barrier is available and can be ordered as a separate part using part number 3A0415-01. As of August 1, 1995, the push button switch part number 435745-01 will sub to part number SA0002 which will include a barrier.

When replacing the push button switch it will be necessary to install the new barrier covering the switch. Please refer to the drawing for the correct position and location.
