# HOSHIZAKI AMERICA, INC.

## SERVICE BULLETIN

**SB99-0011**

### **Subject: DCM Shutter Mechanism**

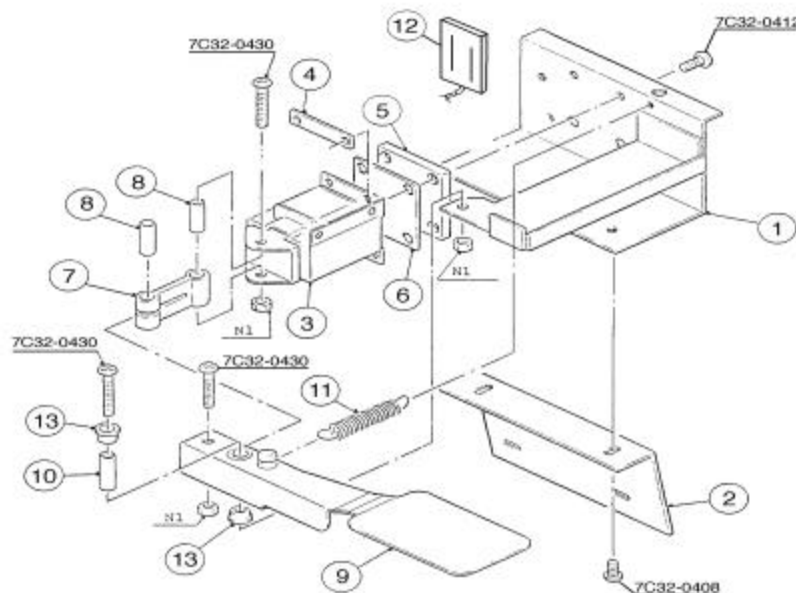
It has been reported from the field that the shutter lever # 9 has been coming loose from the solenoid assembly on new DCM-500 B models. An investigation has revealed that the wrong nuts were used in the assembly process. Evidently, we got our nuts mixed up. The N1 nuts should be the nylon self-locking type. Standard nuts were used on some assemblies and in some cases, lock tight sealant was used. If standard nuts were used without sealant, they will back off of the screw as the shutter operates. This problem could show up on any DCM-500 or DCM-750 model.

**drawing below for the three N1 nut locations.**

The part number for the correct lock nut is 7N22-0400. There are 3 on each shutter assembly. We ask that you order some of these nuts and if you go out on a DCM-500/750 call, check the shutter assembly. Replace the standard nuts with these to eliminate the possibility of a loose lever. If the call is warranty, note that the nuts were changed on the warranty form. See the
