HOSHIZAKI AMERICA, INC.

SERVICE BULLETIN

SB01-0007

Subject: IM-51BAE ACCUMULATOR ANGLE

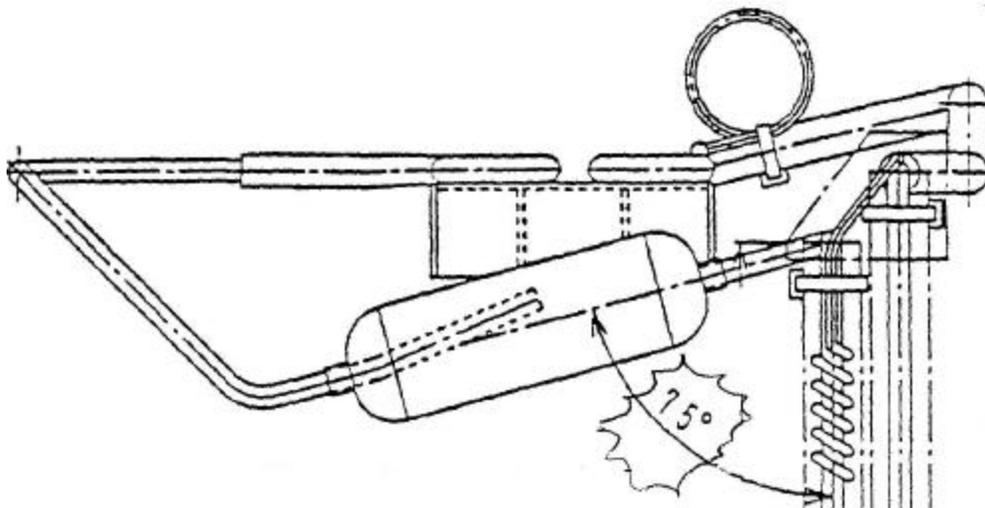
The IM-51BAE has an accumulator on the Evaporator outlet. The angle of this accumulator is critical to the proper operation of the machine. If this angle is too high it could cause the unit to have symptoms similar to an inefficient compressor. This situation could also allow refrigerant to flood back to the compressor causing internal damage.

Attached you will find a drawing showing the proper angle and position of the accumulator. This drawing is shown facing the rear of the unit.

Note: The angle of this accumulator must be checked prior to any compressor change.
