# HOSHIZAKI AMERICA, INC.

## SERVICE BULLETIN

**SB04-0002**

### **Subject: AM-100 AND AM-150 SERIES DOOR GASKET INSTALLATION AND INSPECTION.**

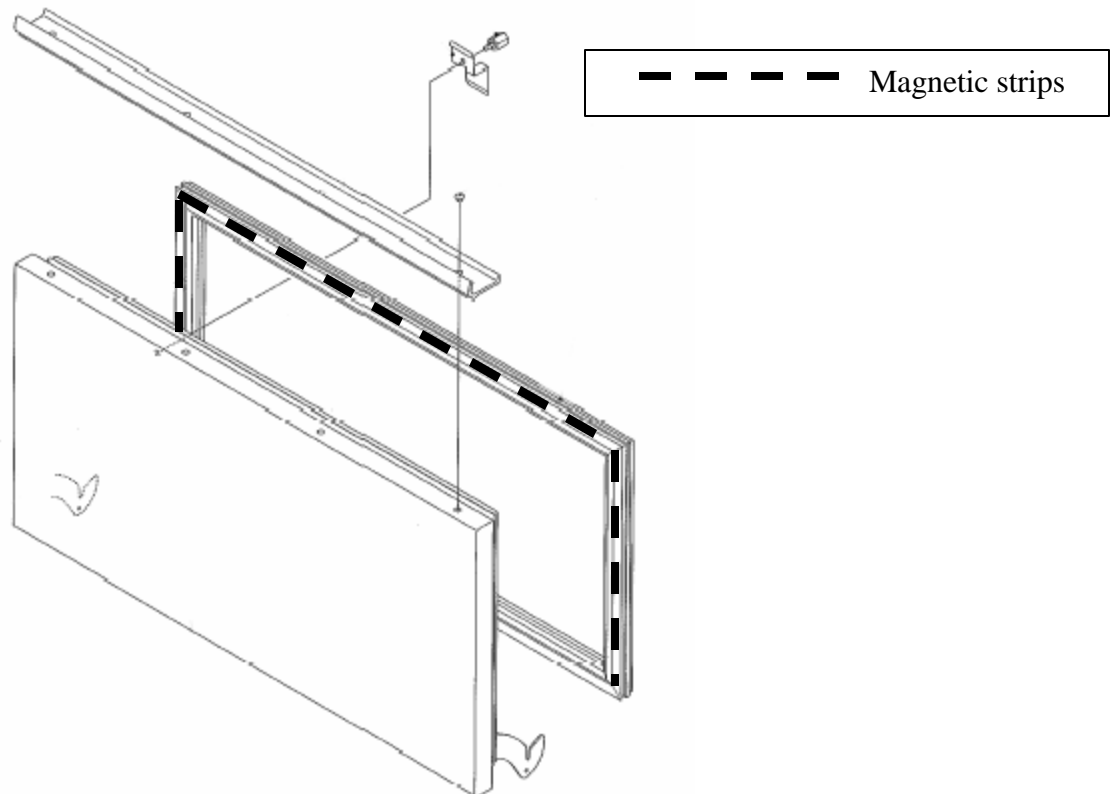
When replacing the bin door gasket on the above models it is important to insure that the door gasket is installed properly. Magnetic strips are inside the gasket on three sides. The gasket must be installed with the magnet on the right, left and top of the door. The bottom of the door gasket has no gasket.

AM-100 and AM 150 series door assembly

The position of this gasket should also be checked when ever responding to a call where the door falls open or is pushed open before the unit shuts down on the bin control.
