# HOSHIZAKI AMERICA, INC.

## SERVICE BULLETIN

**SB95-0005**

**SUBJECT: Wiring diagram correction KM-1600SWE3**

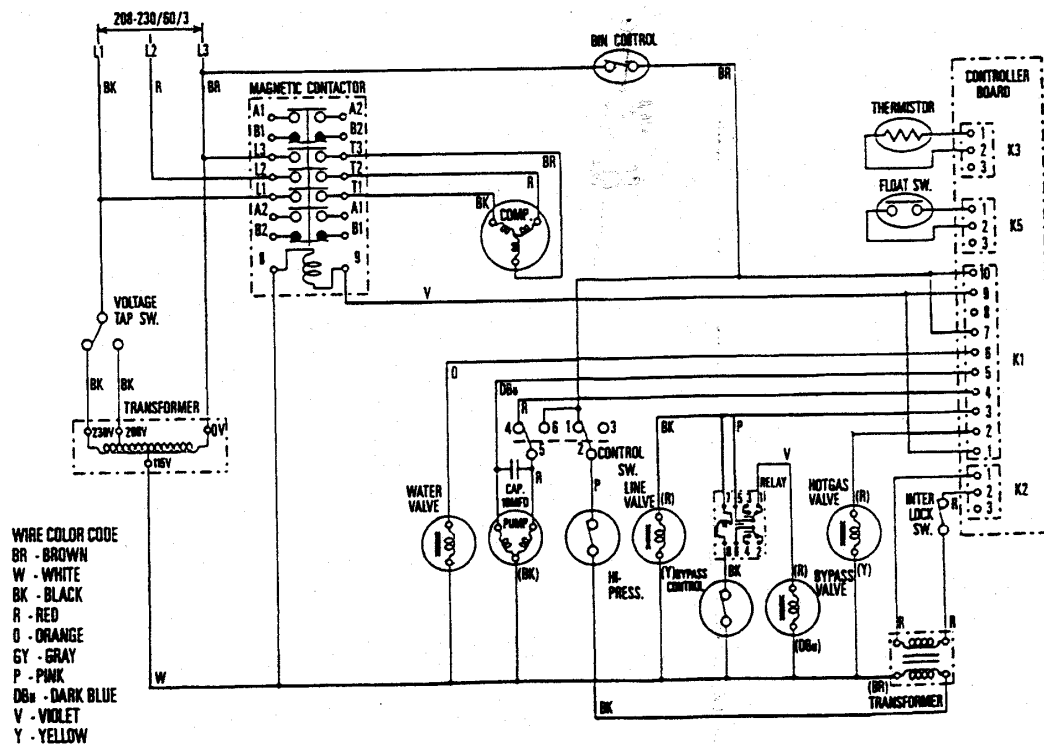
Recently we were made aware of a mistake in the wiring diagram in the composite Service Manual, Service Keys, and the Tech-Spec's. This mistake was also made on the wiring label part number 331319-01 which is installed on the control box of the unit. The wiring diagram below is the corrected version.

The units were wired correctly on the assembly line. **The problem is that the wiring label on the control box does not match the unit wiring.** The mistake was the point of connection for terminal 5 on the bypass relay. It connects to the liquid line valve circuit as shown below and not to the hot gas valve circuit.
