# HOSHIZAKI AMERICA, INC.

## SERVICE BULLETIN

**SB96-0008**

**SUBJECT: DCM 240, 241, 231 GEAR MTR. AND LOWER HOUSING CHANGE**

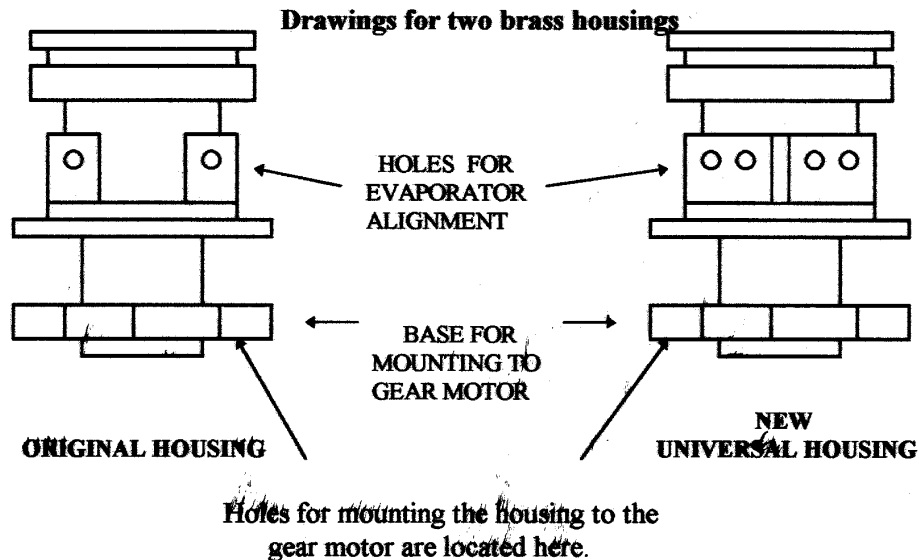
The original brass housing can be identified by noting the 4 mounting holes located around the middle of the housing. These holes are for attaching the evaporator to the housing. Some universal housings have 8 holes in this area for evaporator alignment. This original brass housing # 206013G02 is also no longer available. If the bearings fail on this original housing, save it. You must get new bearings pressed into your original housing using the Hoshizaki bearing press program. If this housing is damaged the only alternative is to purchase a new gear motor #2U0147-01 and a new housing # 206013G03.

**Extra care should be taken to protect the original housing from loss or damage. Installing a new housing on a ( A ) or ( B ) gear motor will result in the misalignment of the evaporator, bin, and ice chute assembly.**
