HOSHIZAKI AMERICA, INC.

SERVICE BULLETIN

SB20-0002

Subject: RE-BUILDING of CKD WATER INLET VALVES *(This bulletin supersedes SB97-0002R & SB01-0009R1)*

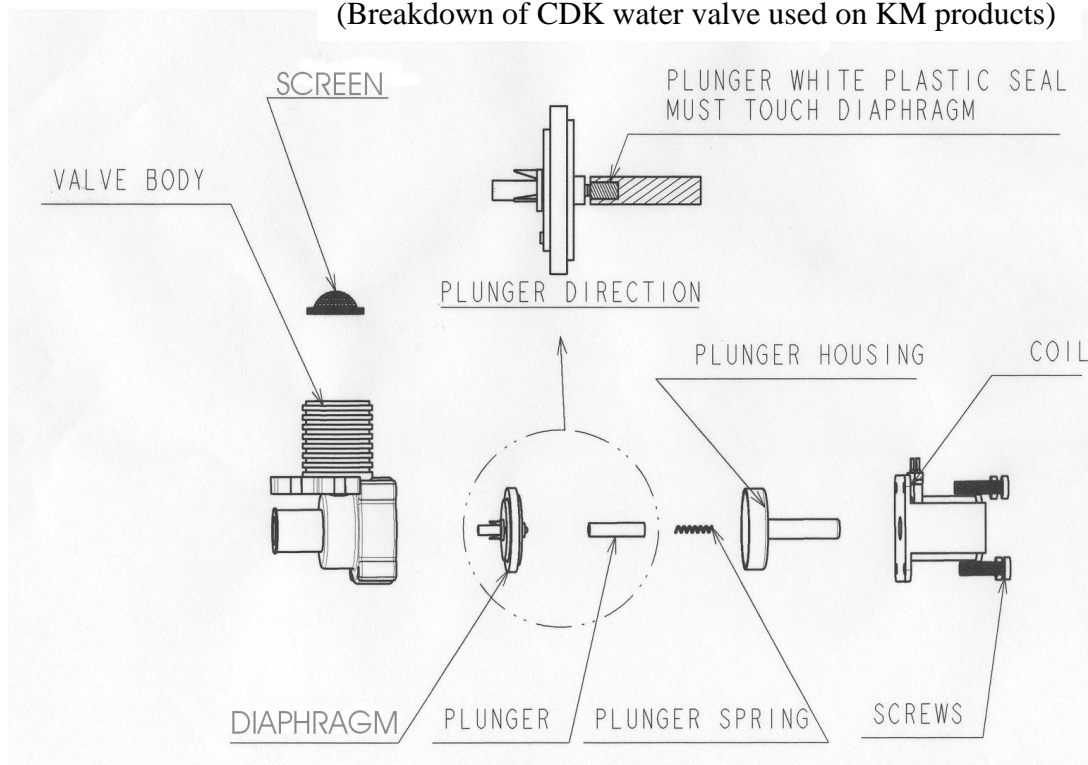
After reviewing warranty returned CKD water valves, many times we find that the valves have not been re-assembled correctly. Below you will find an exploded view of the valve assembly and instructions on the proper re-assembly of the valve.

(Breakdown of CKD water valve used on KM products)

When the valve is re-assembled after replacing a diaphragm. It is important that the plunger is installed in the correct position. This plunger has a white plastic seal on one end and is metal on the other. The white seal end of the plunger must be in contact with the diaphragm for the valve to work correctly.
